Materials Selection Challenges in the Refining Industry

Dave Cooke
Consulting Materials Engineer
Chevron Energy Technology Company

August 2014
Richmond, CA

2014 AIChE/SACHE Faculty PSM
Workshop

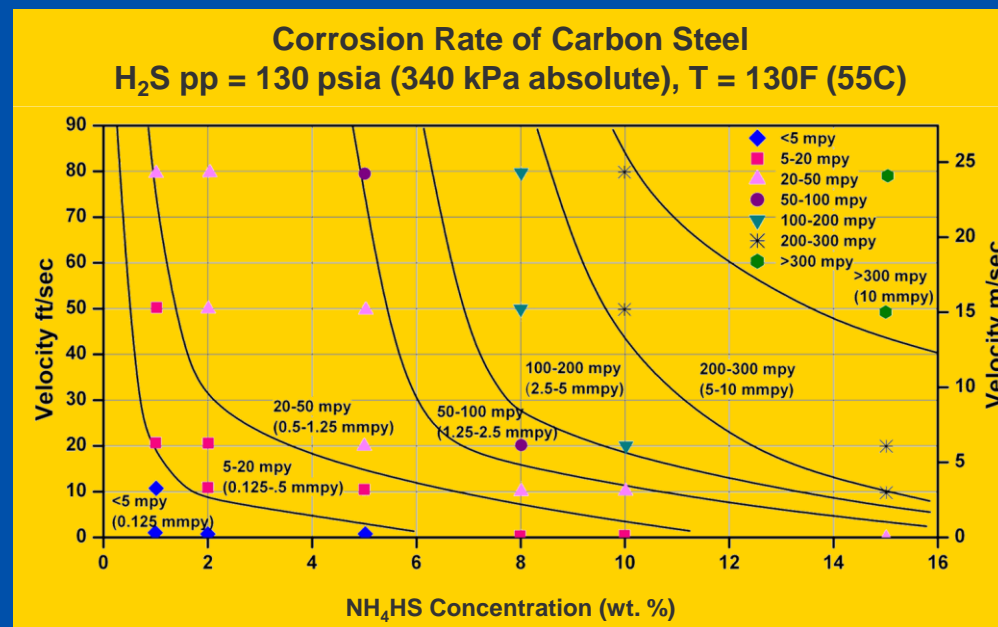
Ammonium Bisulfide Corrosion

- Empirical observations and field data were helpful, but unexplained failures continued to occur
- Joint industry project conducted over 10 years to systematically study the phenomenon and develop correlations for the key factors
- A commercially available software package was developed which provides reasonable predictions of corrosion rates
- Now widely used by industry for aiding materials selection, establishing operating limits, and setting inspection requirements.

Source: NACE Paper #06576 Prediction and Assessment of Ammonium Bisulfide Corrosion Under Refinery Sour Water Service Conditions (used with permission)

NET RESULT: Corrosion is now predictable and therefore manageable

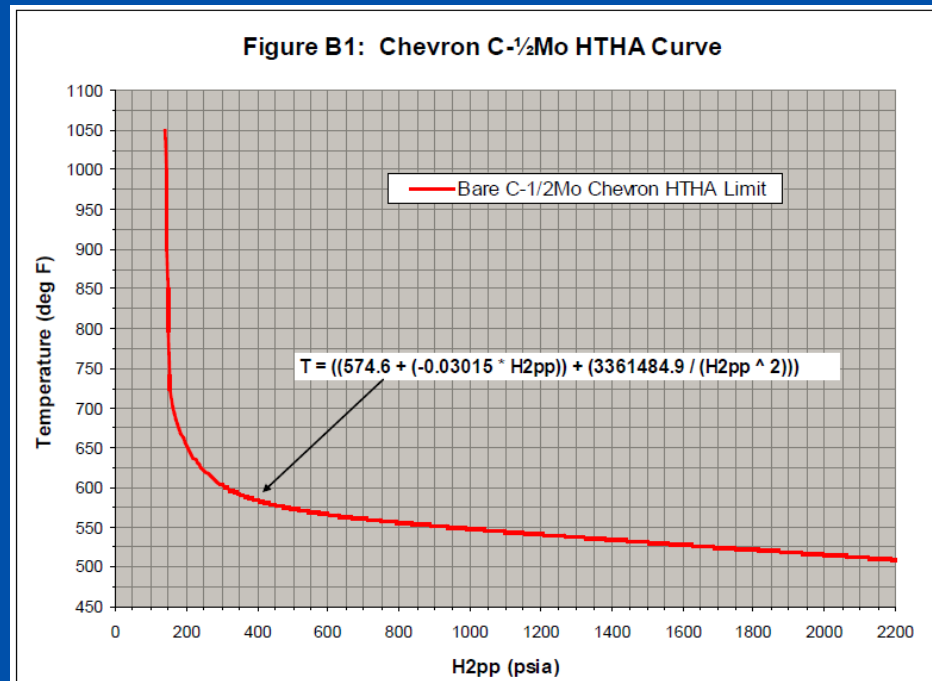
API RP 941 Figure 1 Contains Limits for Ferritic Steels to Prevent High Temperature Hydrogen Attack

- API RP 941 Figure 1 shows six curves for six different alloys, indicating regions of hydrogen attack susceptibility based on empirical data
 - Hydrogen partial pressure vs. temperature
 - An example of this relationship is shown below for C-1/2Mo

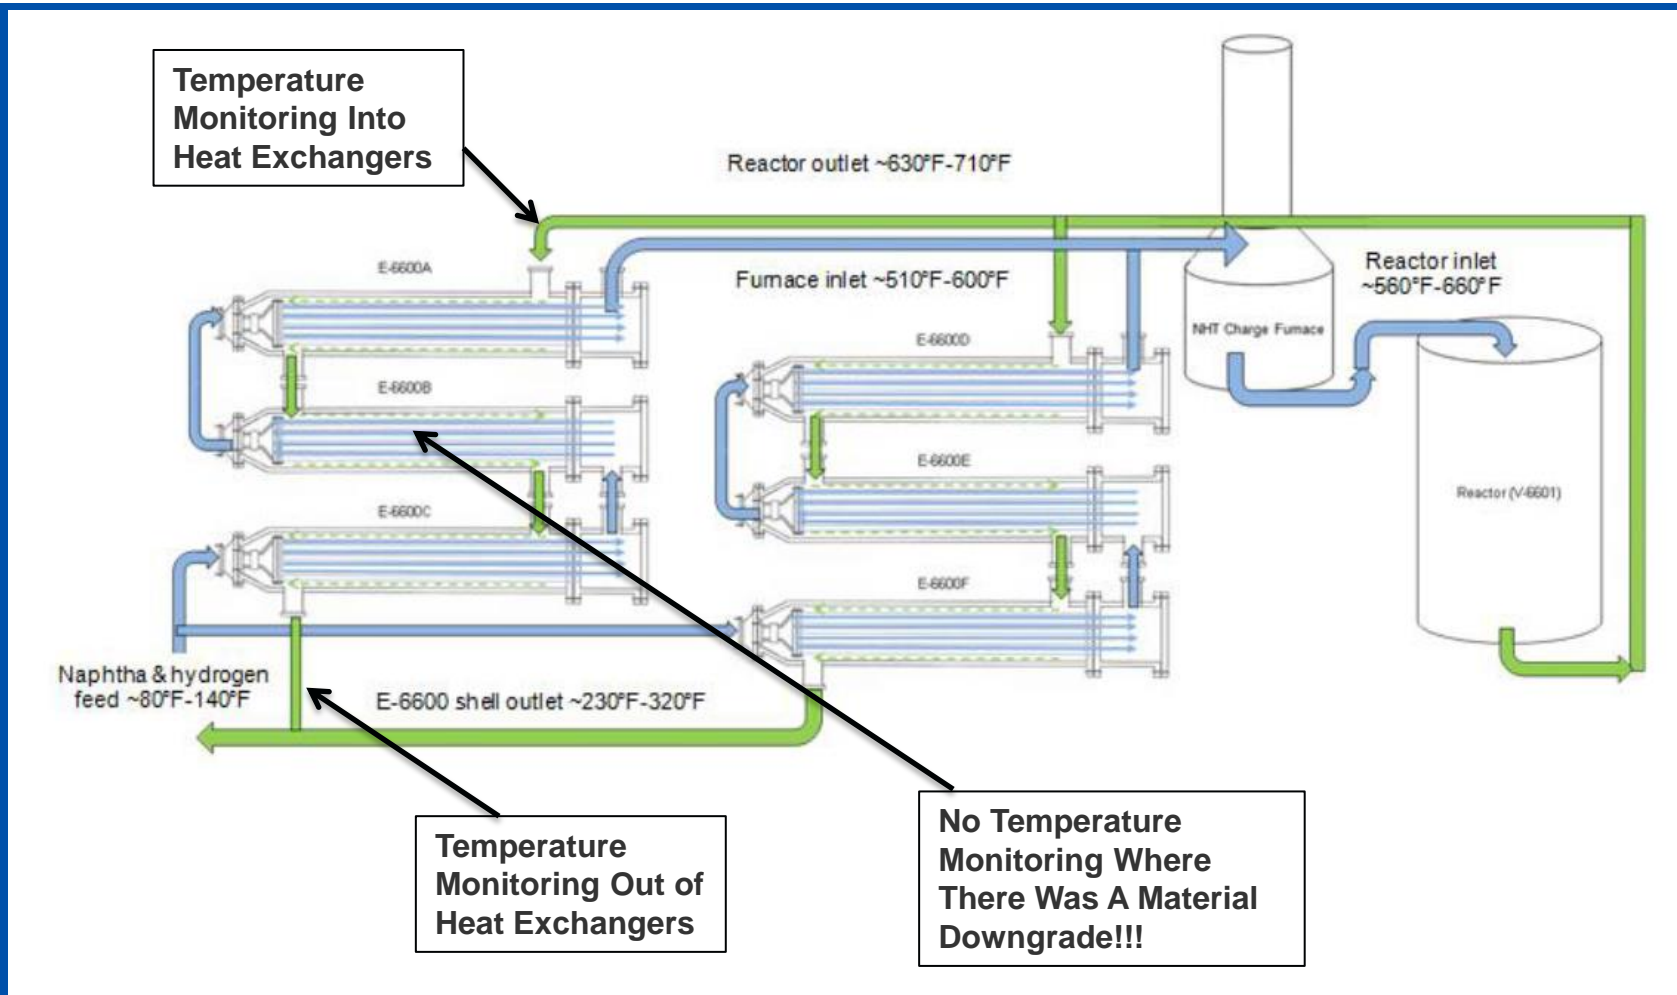
The Naphtha Hydrotreater (NHT) Process

Figure taken from Tesoro Anacortes NHT Investigation Report, July 21, 2011. Copyright 2011 Tesoro Refining & Marketing Company LLC. All rights reserved. Used by permission from Tesoro.

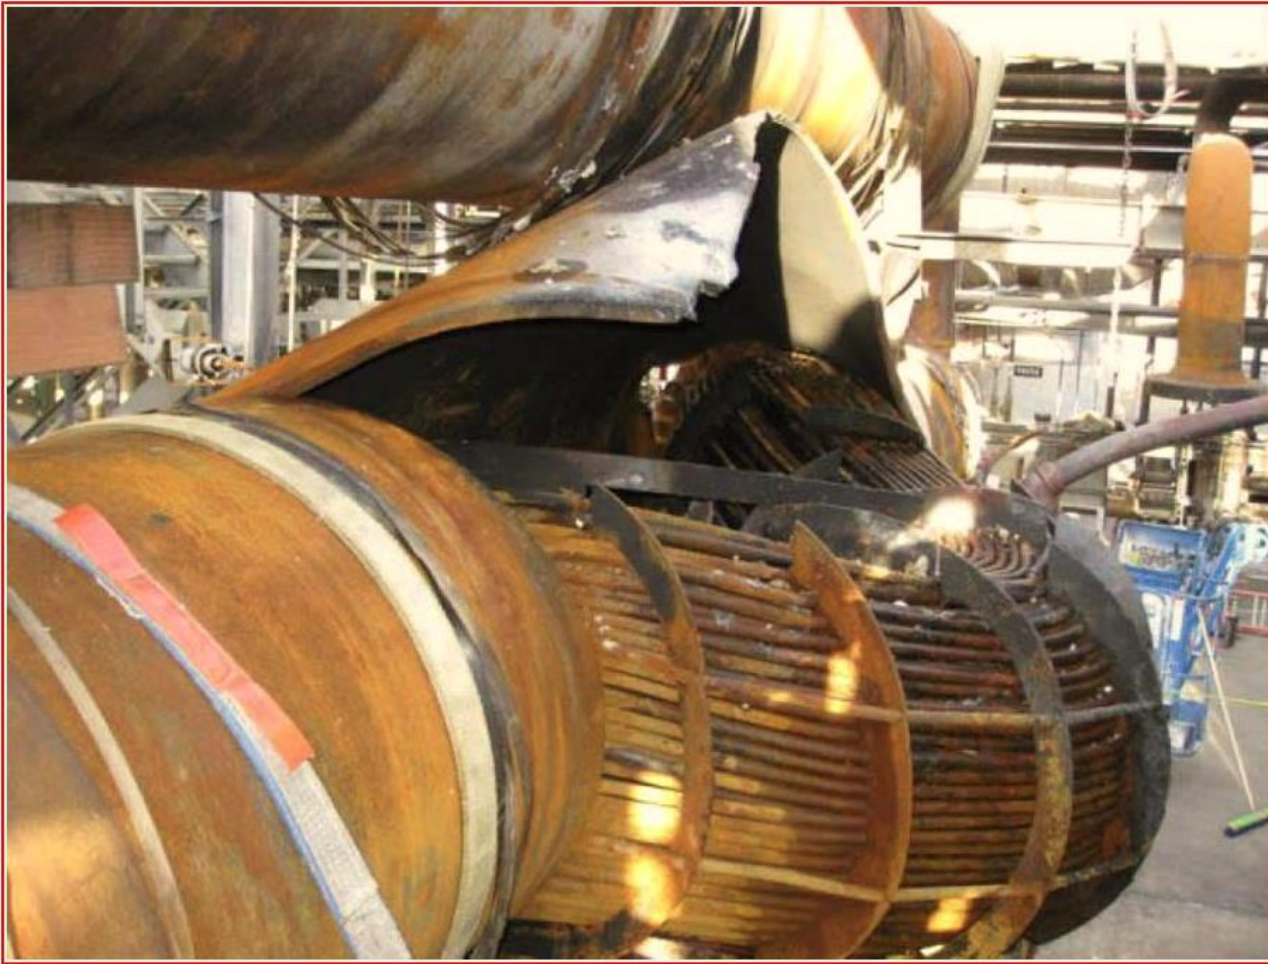
Tesoro Anacortes 2010 Heat Exchanger Shell Failure Due to High Temperature Hydrogen Attack

This Incident
Resulted in
Several
Fatalities

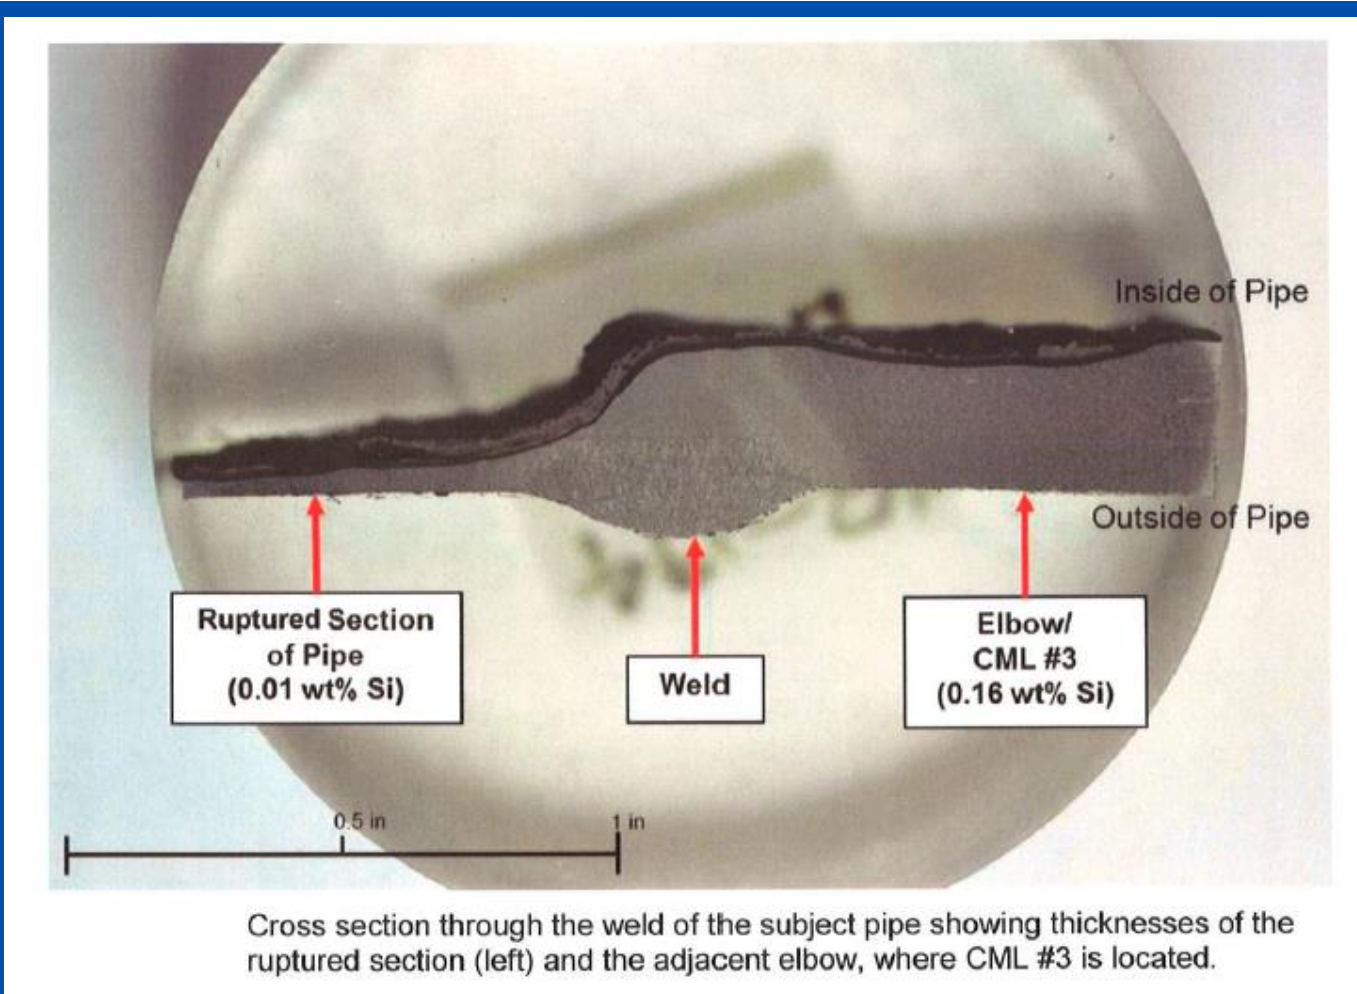
Cross section through the weld of the subject pipe showing thicknesses of the ruptured section (left) and the adjacent elbow, where CML #3 is located.
